City of Alexandria Storm Sewer Capacity Analysis (CASSCA)

Holmes Run Condition Assessment

PREPARED FOR: City of Alexandria, CH2M Hill
PREPARED BY: Baker
DATE: March 20, 2013 (Revised May 26, 2015)

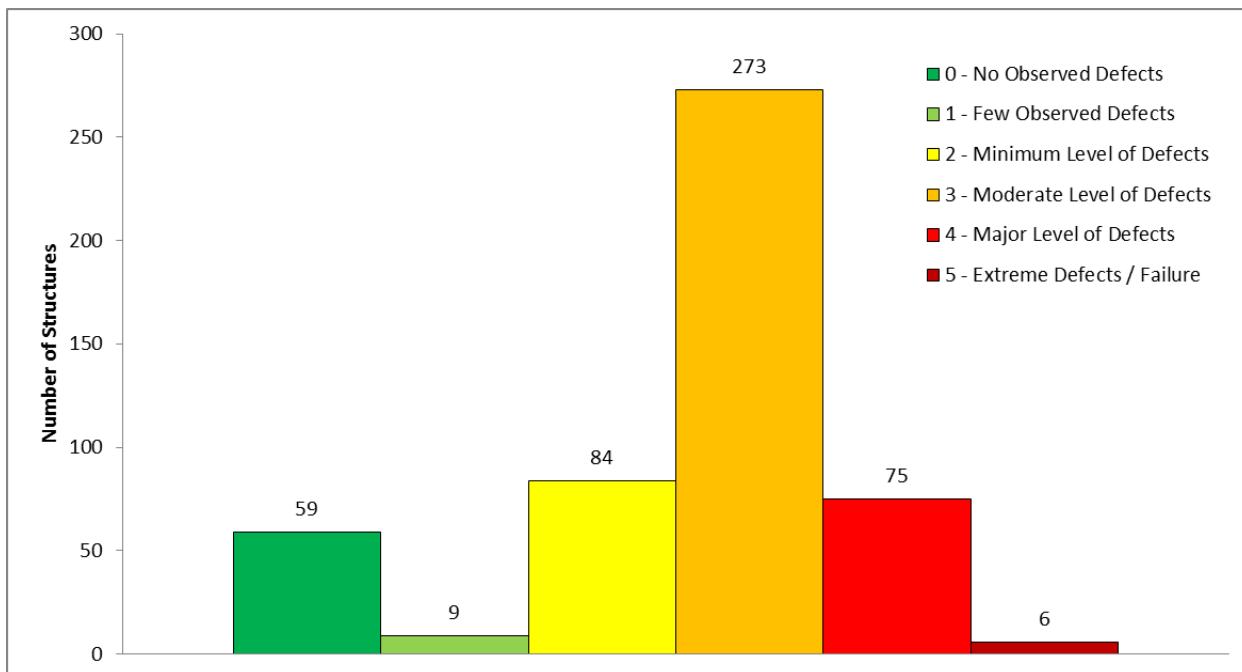
Figure 1 is a summary of the inspection results by severity of structure condition score. Figure 2 is provided to show the location of each structure within the Holmes Run watershed, color coded to the defect categories listed above. The average condition score of 506 storm structures inspected within the Holmes Run watershed was 45 (Moderate). Six (6) structures had scores 81 or higher, placing them in the major and extreme categories. About 13% of the structures showed few to no defects, while the remaining 71% of structures ranked in the minimum to moderate defect categories.

Figure 1. Structure Inspection Summary.

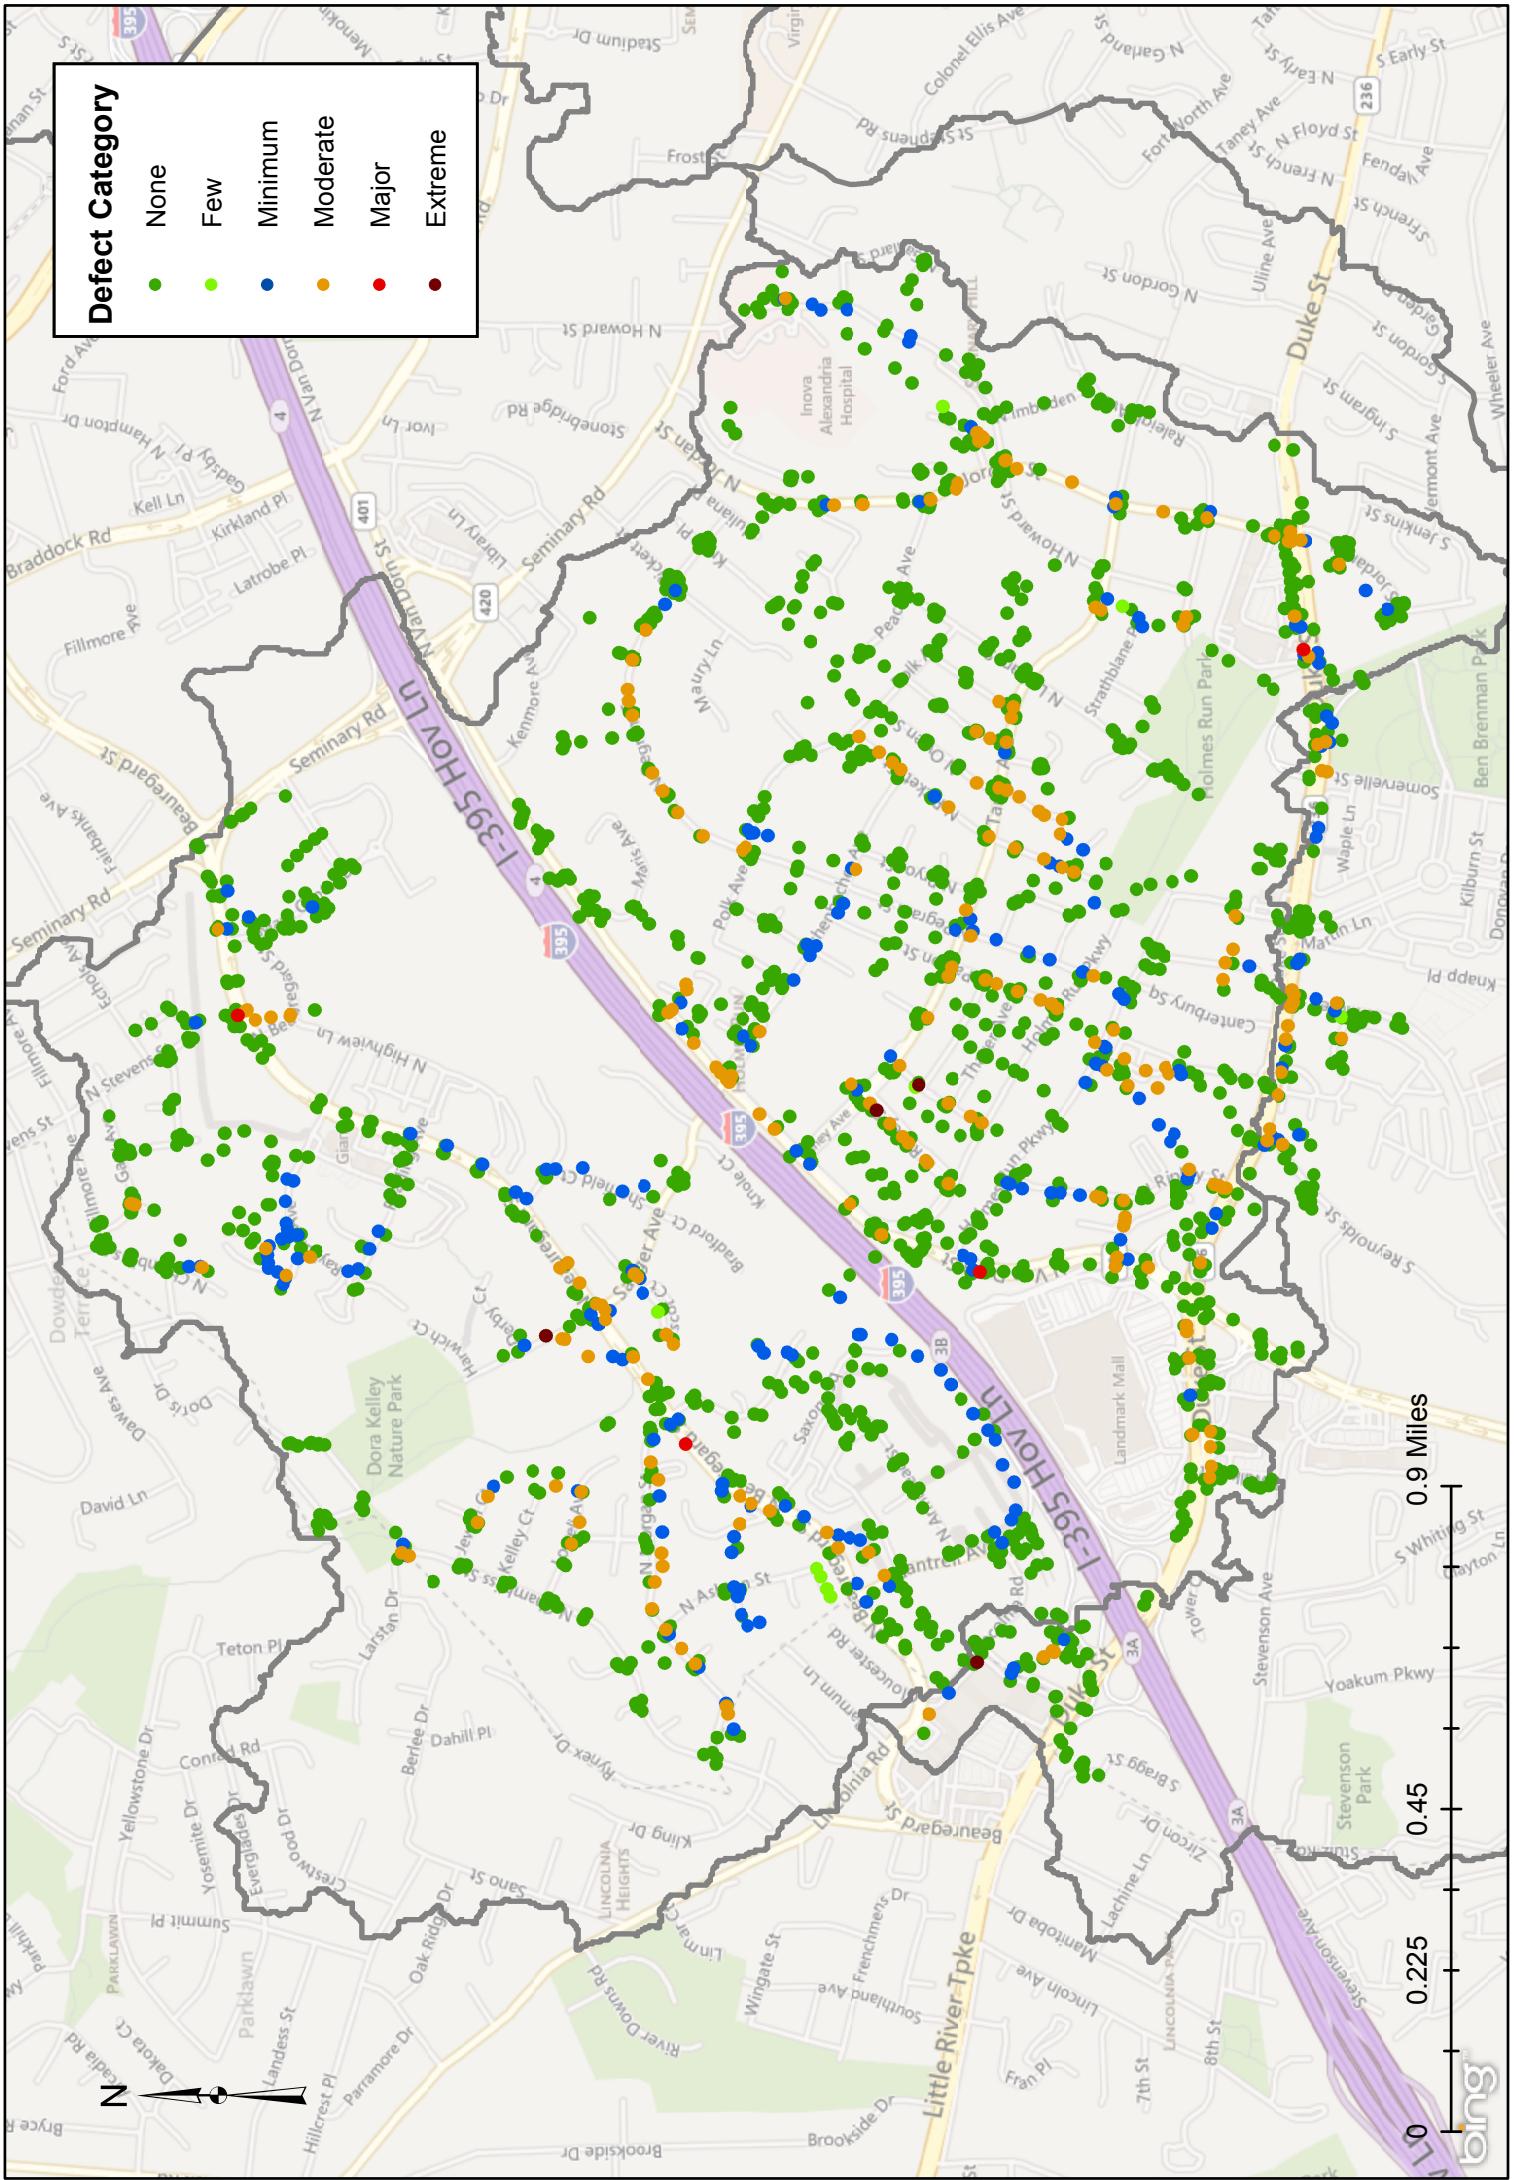
Figure 2. Overall Condition of Storm Structures (Color coded by Severity of Defects).

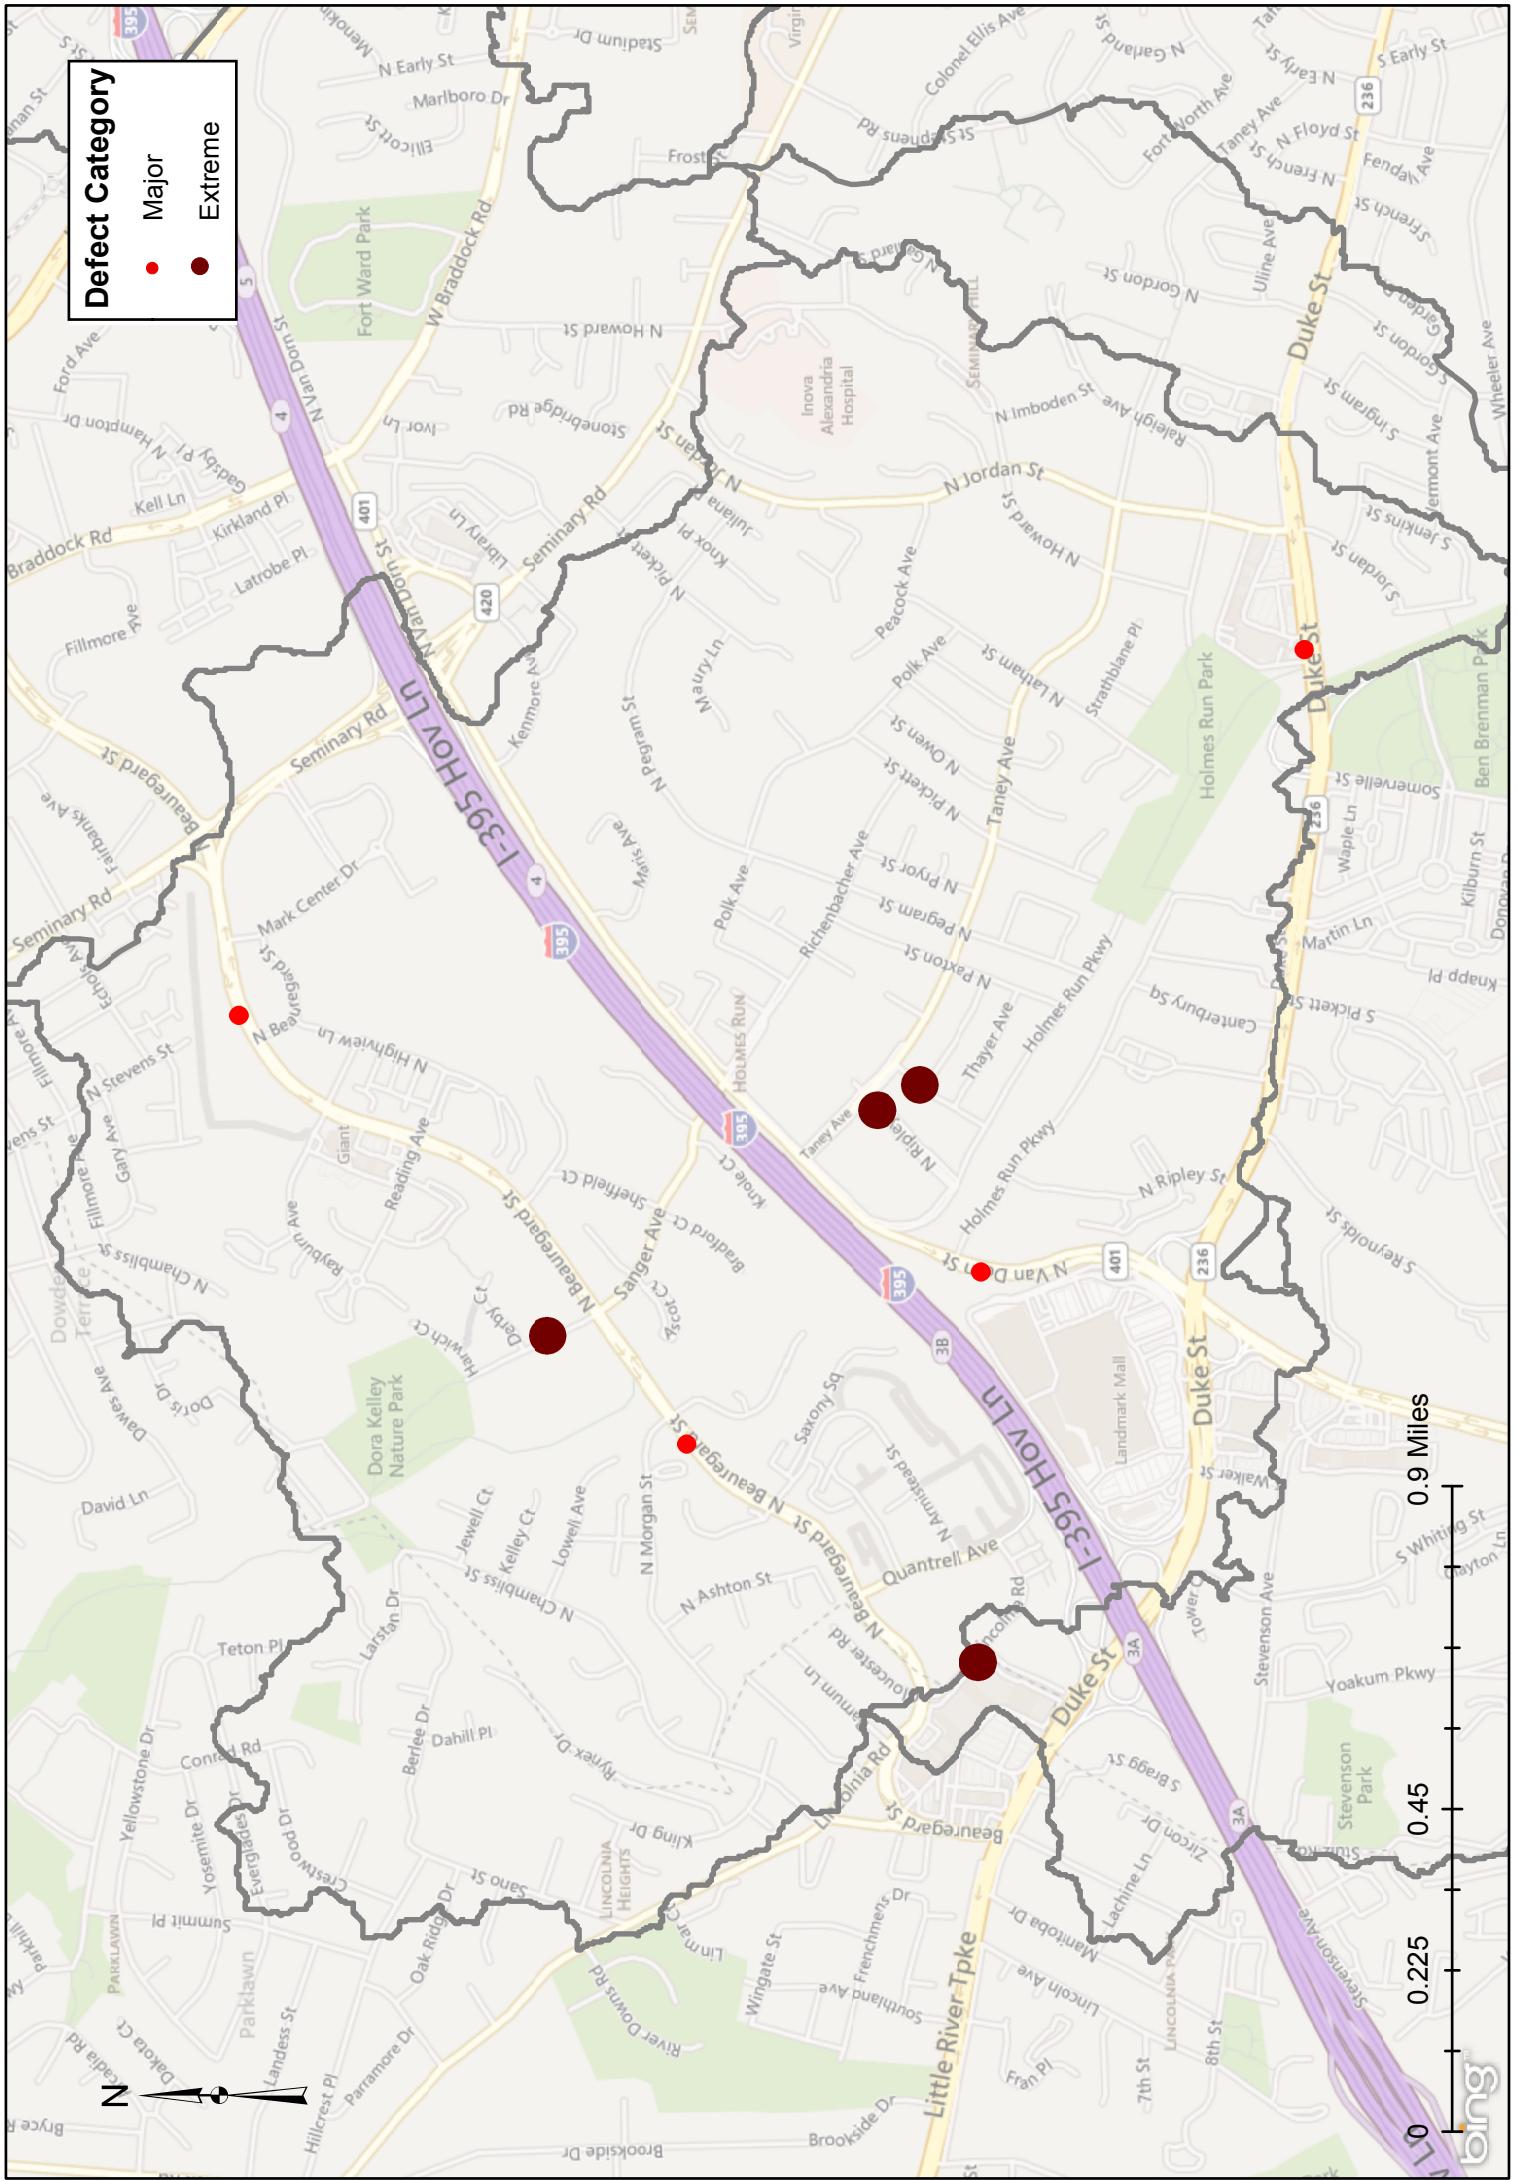
Figure 3 displays the location of the structures classified with major and extreme damage only. The structures with high defect scores are mainly distributed along N Beauregard Street and Taney Avenue on both sides of I-395. The inspections of the structures were broken down by structure component for further detailed condition assessment. Table 2 lists the number of observed defects, by component and severity. The table shows a count of the number of defects found in each component and their respective severity; not the number of inspections performed. Multiple defects may be found in a single component of a structure.

Figure 3. Location of Storm Structures in the "Major" and "Extreme" Categories (Color coded by Severity of Defects).

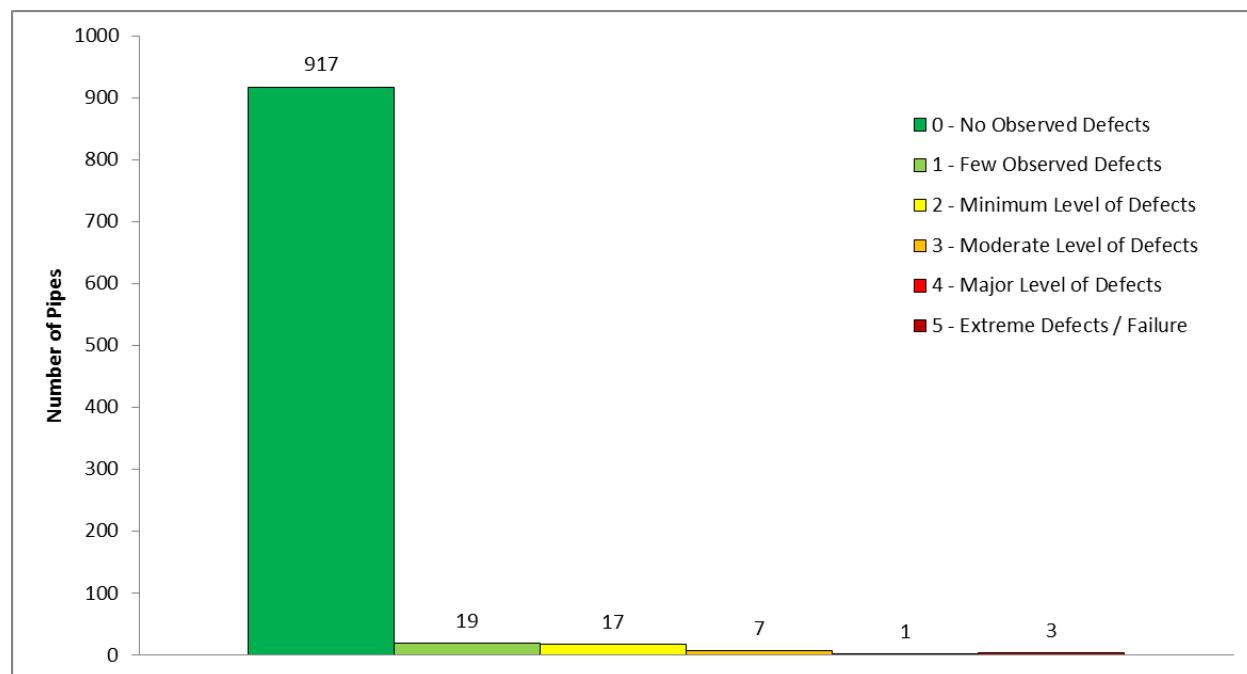
Figure 13 shows a summary of the inspection results by severity of the pipe defect. Figure 14 shows a map of the location of each inspected pipeline, color coded by defect severity. The average condition score of 964 storm pipe segments inspected within the Holmes Run watershed was 1.6 (Few to No defects). Inspection results in Holmes Run watershed showed that the pipe segments were observed to be in generally excellent condition, with no defect observed in 95% of the pipes.

Figure 13. Pipe Lamping Inspection Summary.

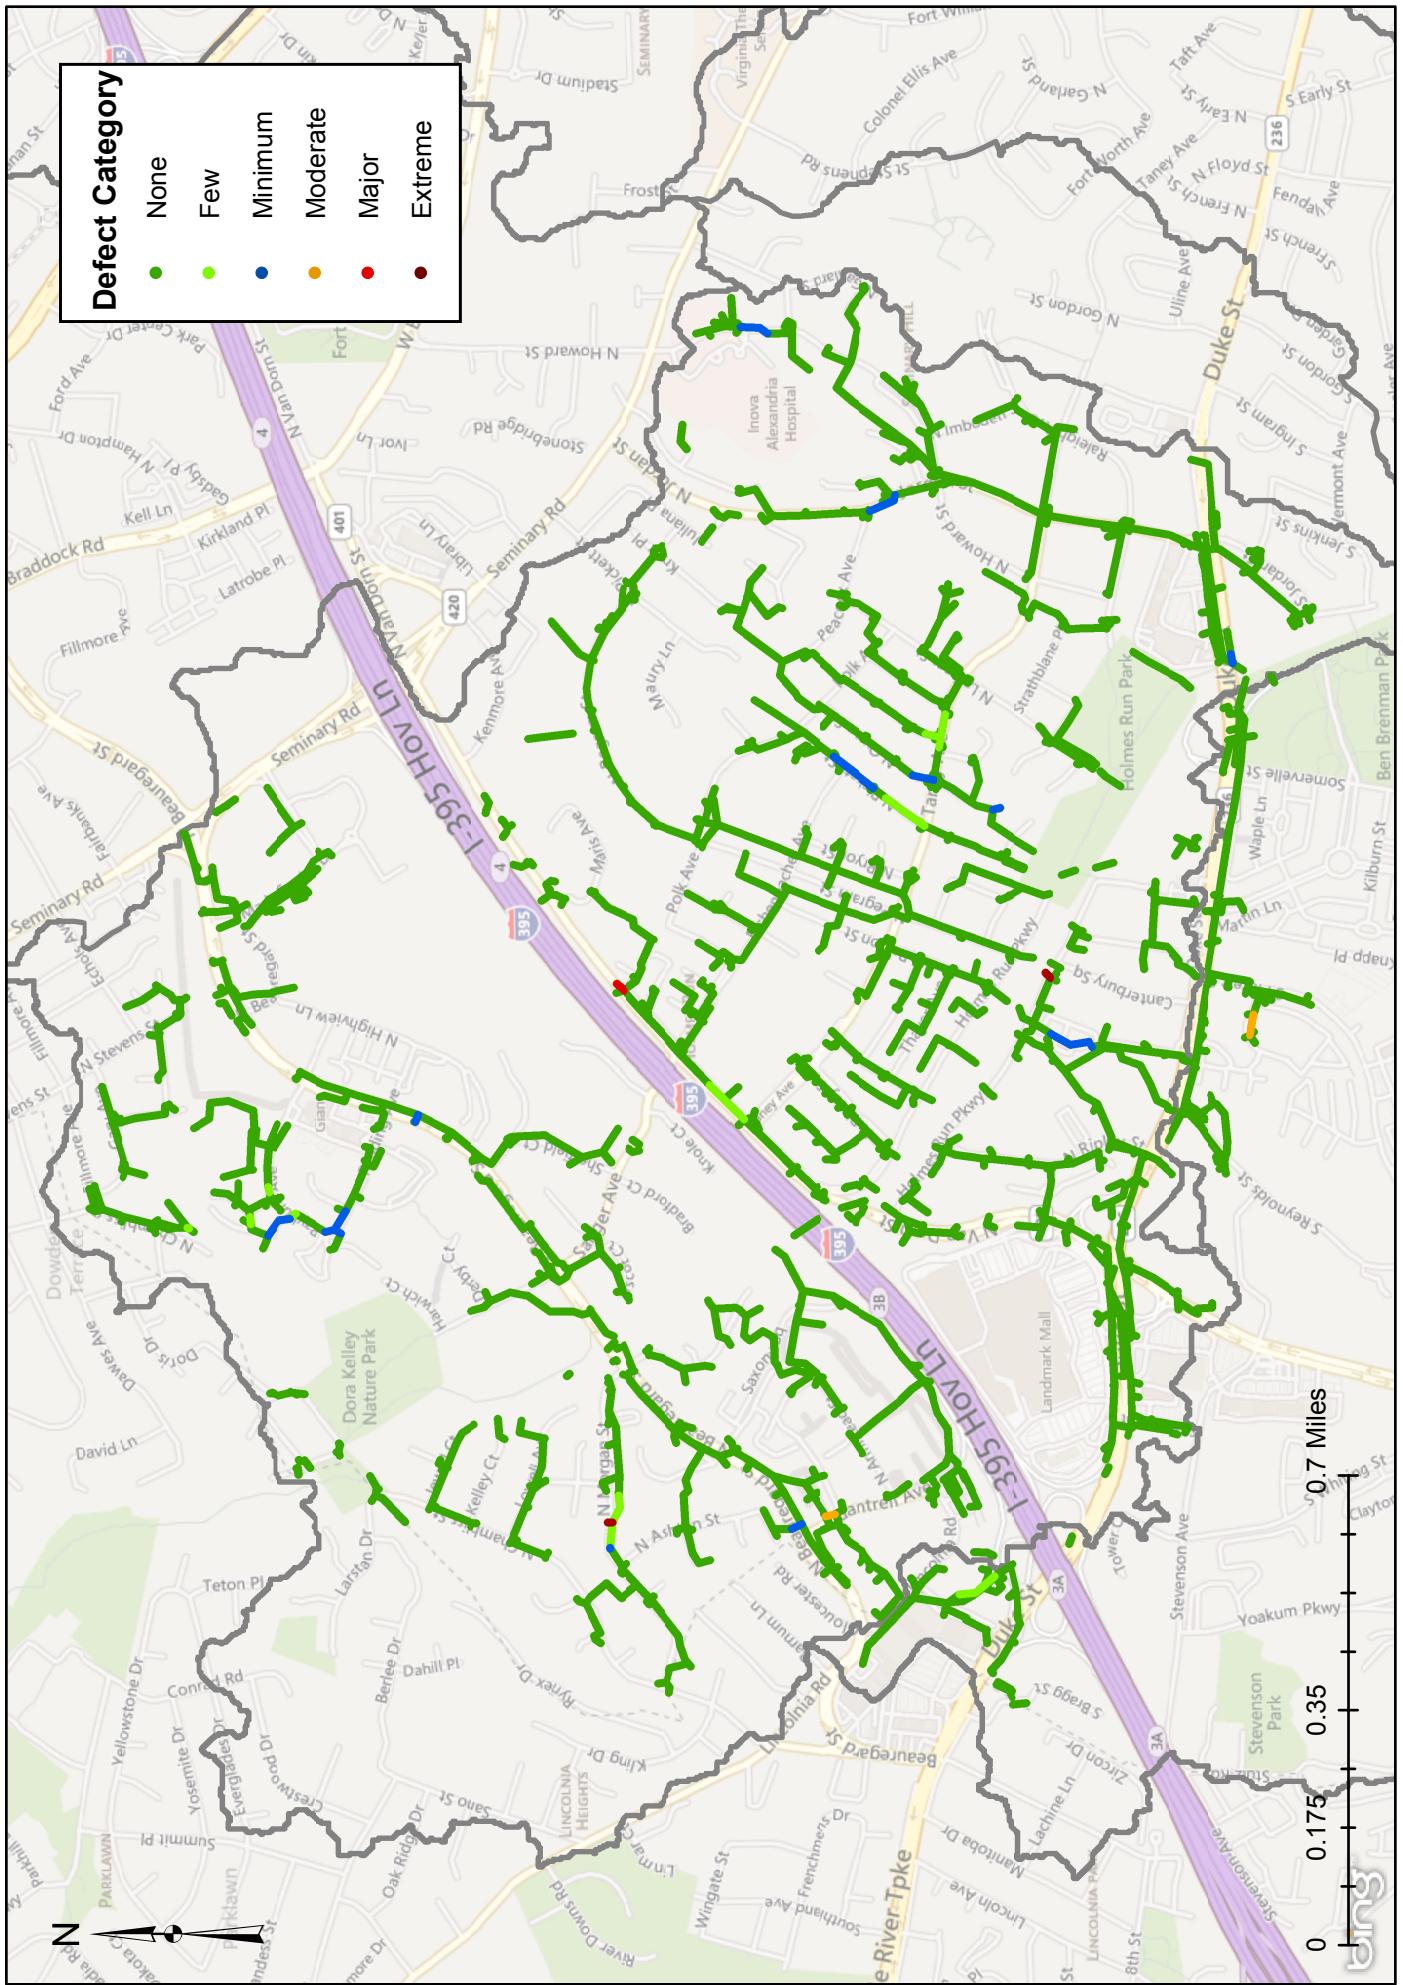
Figure 14. Overall Condition of Storm Pipelines (Color coded by Severity of Defects).
